Religious buildings in Ortahisar (turkey).the Survey of the complex of Saklı and Ali Torun kilise. Hypogea 2015 - Proceedings of

The survey of Saklı Kilise and Ali Torun Kilise complex District Eski / Atik Mahalle

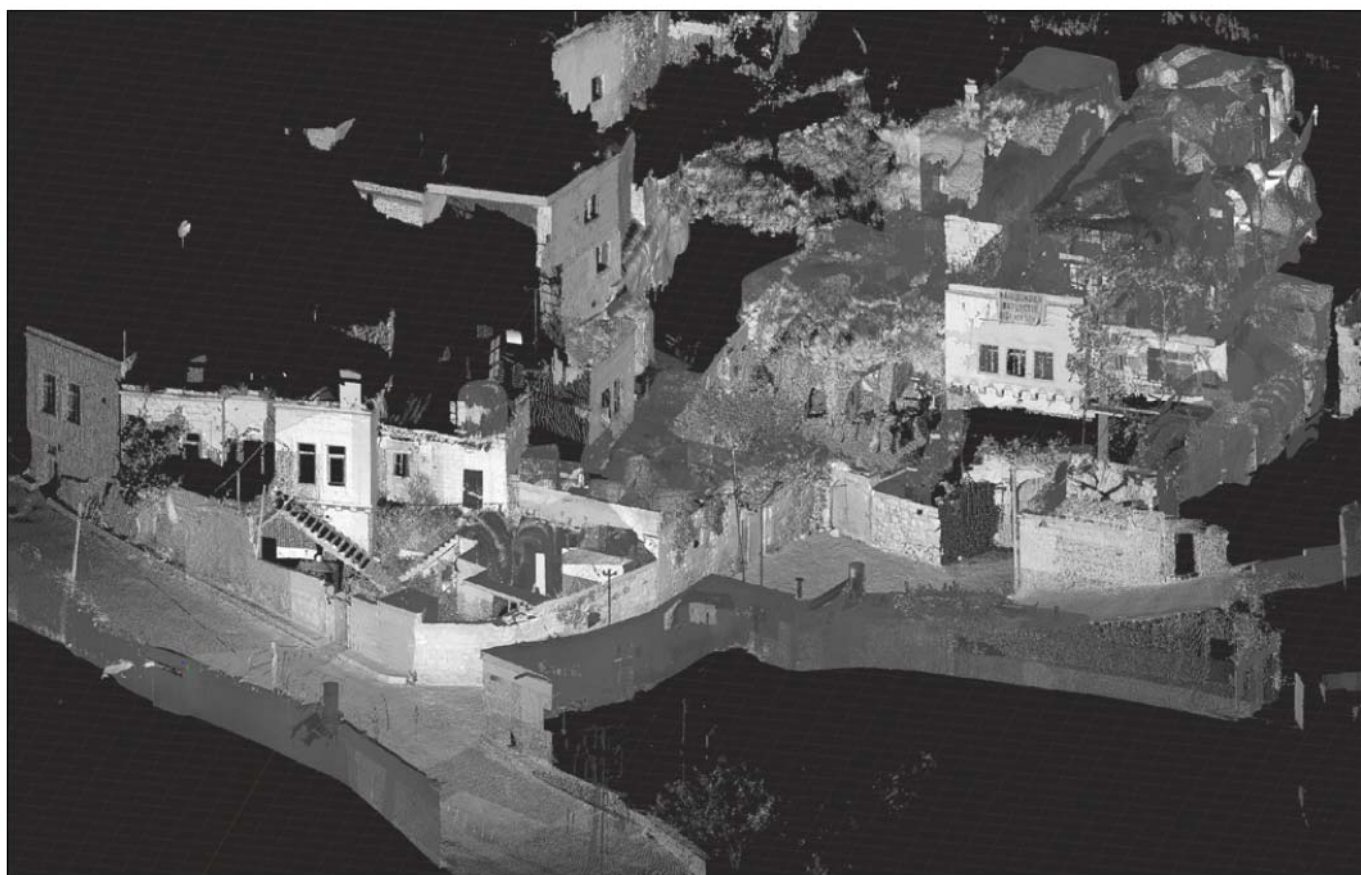
Fig. 3: Saklı and Ali Torun Kilise. Axonometric view of the complex. Point clouds.

2013 the complex passed on to the three heirs of the original owner (Fig. 3-4).

Ali Torun Kilise (coord. 38.61953; 34.86604 WGS4) Outside the Saklı Kilise, in the area closing the path to the NW, an high wall with a particular entrance arch surrounds the courtyard, leading to the Ali Torun Kilise (Fig. 3) (CRESCENZI C., 2012).

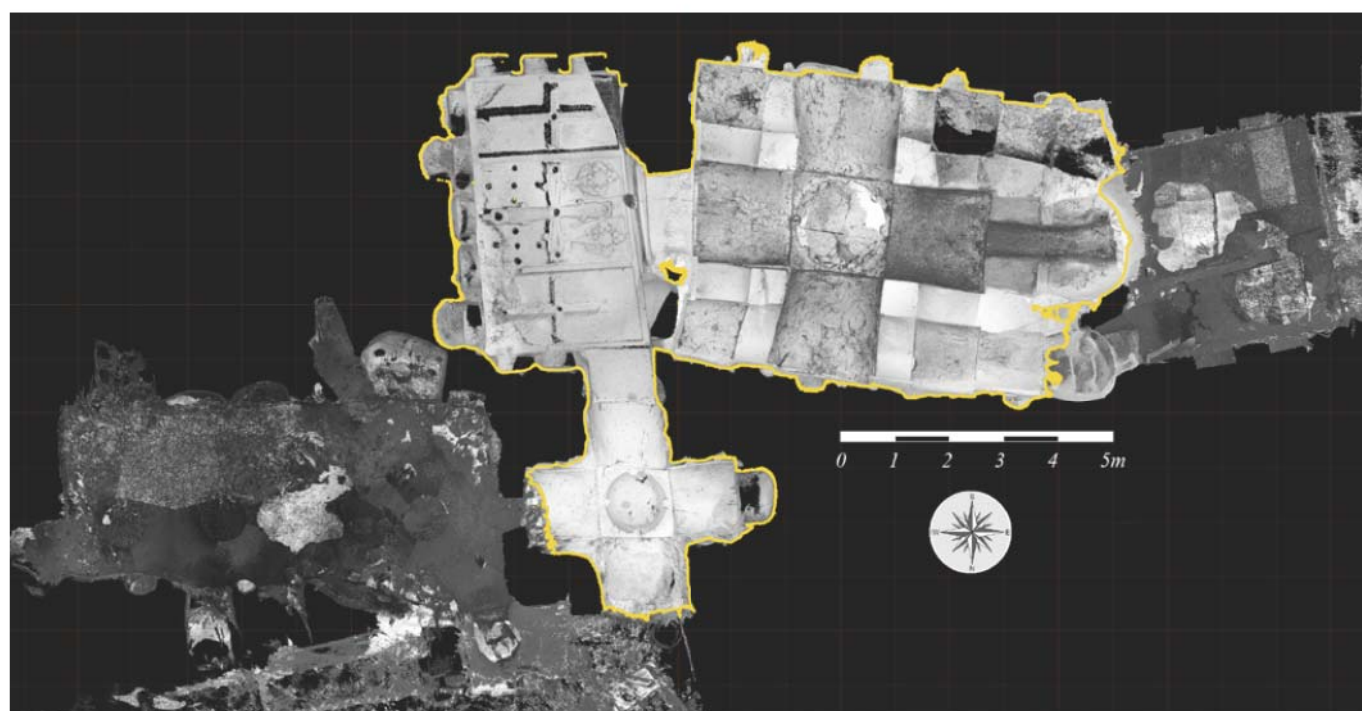
Fig. 5: Saklı Kilise. Bottom view of the vaults.

A wide door (1.57 m) communicates with the narthex (5.07 m x 2.86 height 2.41 m) (Figs. 5-6).

The E wall of the narthex is articulated in three parts: the entrance is framed with geometric frames and is flanked by two blind niches, that partly destroyed the bottom. The W wall has five blind niches, while E only three are at the N and S walls; specifically, the N has two blind ones, and in the third there is the passage for the small building of a Greek cross (Figs. 5-6-7).

In each of the upper panels of this cross, at a lower level, is sculpted a cup that still contains a cross with arms polylobate; in the panels below, there is still a cross figured five *cuppelle* (Fig. 5) (BIXIO R., DE PASCALE A., 2012).

The passage NE of the narthex leads into a small building with a Greek cross (3.9 x 3.9 m, height 2.51 m) (Figs. 5-7-8). A small apse (width 0.84 m, depth 0.81 m) is oriented to the E. Twinned niches were carved on the walls of the arms (0.31 x 0.63 m), some still visible. In the central span (1.076 x 1.07 m), on a small circular frame, the tambour (diameter 0.96 m, height 0.45 m) and the hemispherical dome (height 0.473 m) are set.

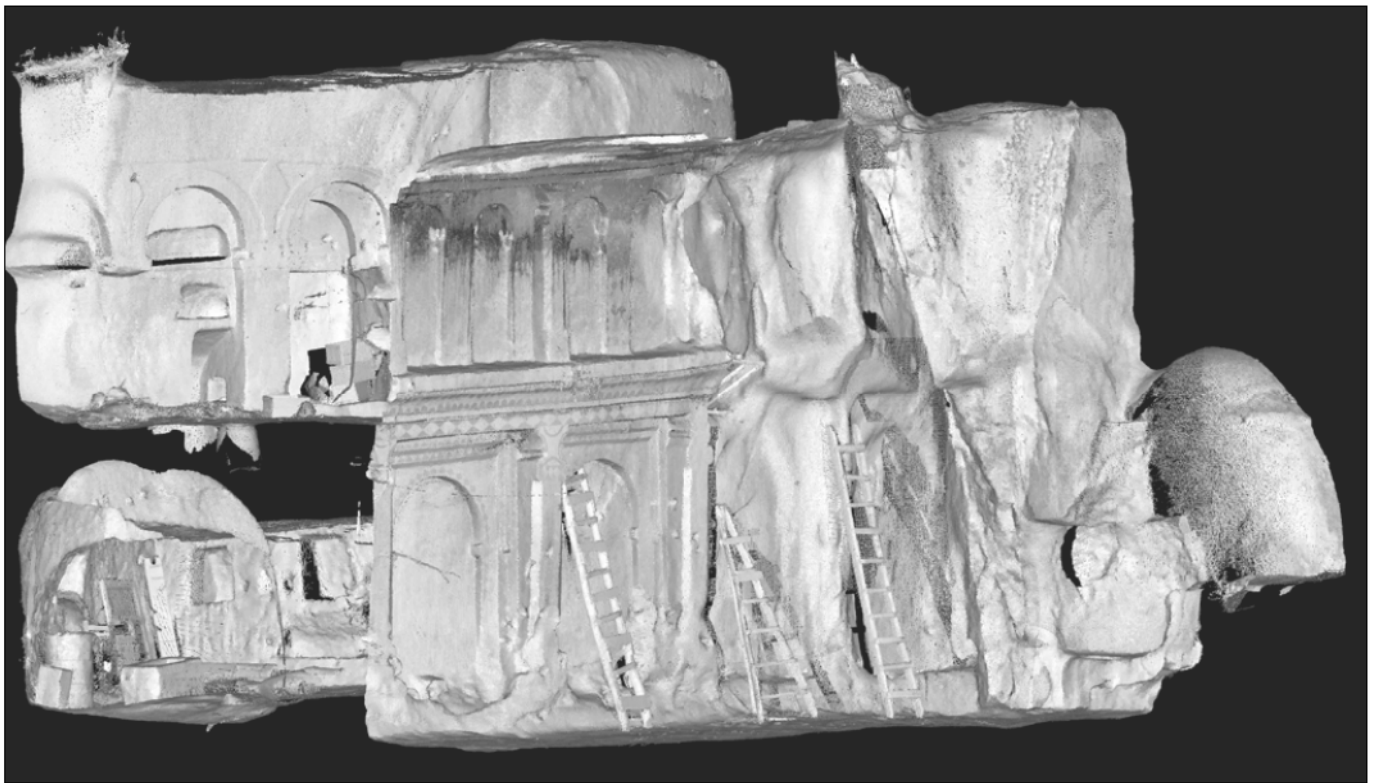
Fig. 10: axonometric section view of the hall church and the chapter house.

The roof of the nave is free from constructions that occlude the rocky facade, and the apse part is located under the street. The height is divided in two architectural orders; the lower, in turn, is divided by blind niches with double pitch compared to the superior one. On the basement there are residual traces of *subsellium* and a further raised element from which starts the pedestal of the pilaster (Fig. 10).

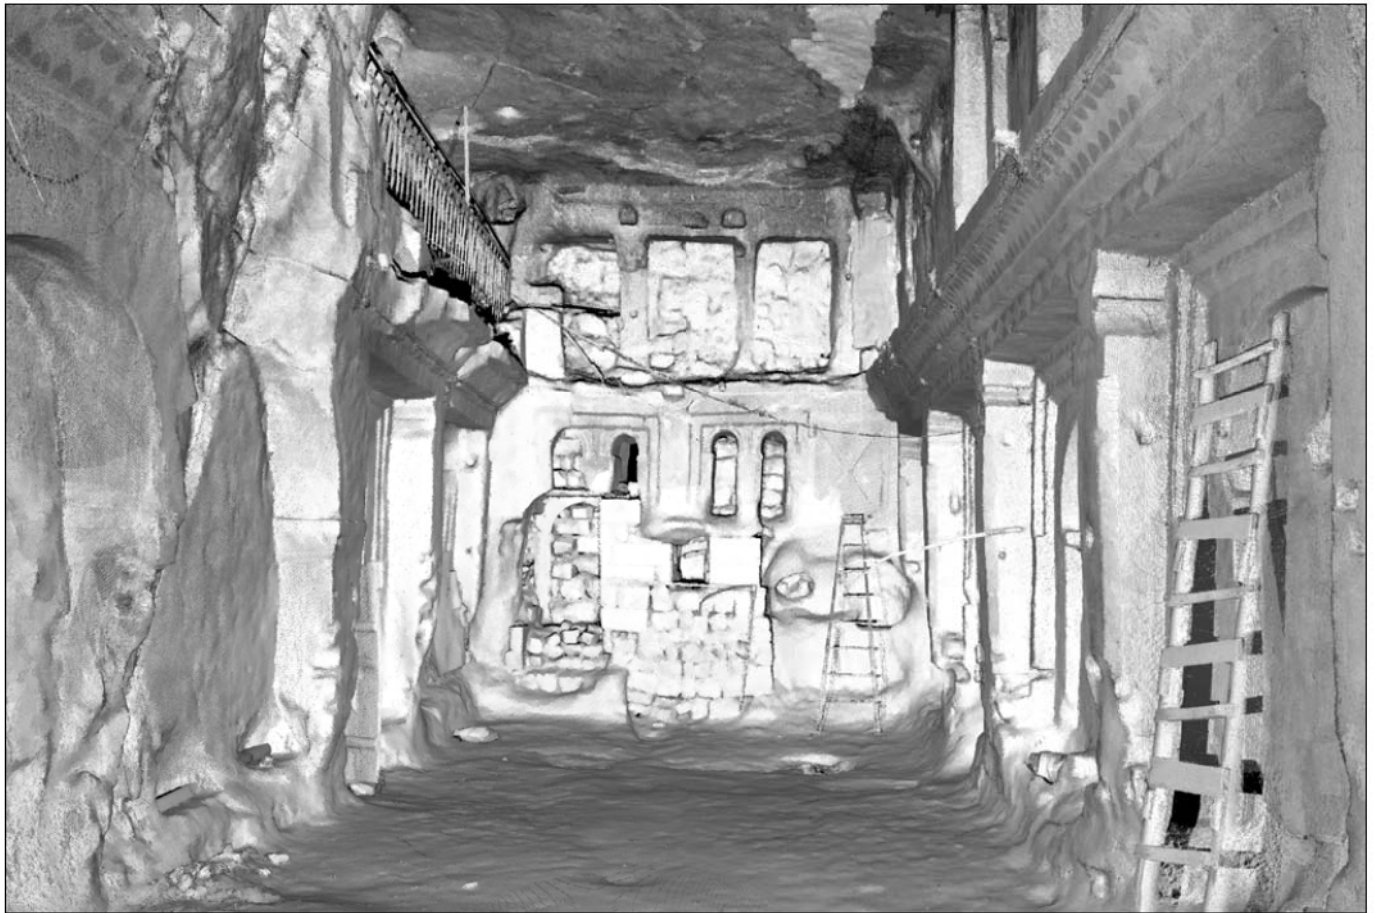
Fig. 13: perspective from the ESE.

The ESE wall, by the interior side, is architecturally relevant. On the superior order there are three wide opening, different in width, divided by pillars. On the right corner there is a walled opening; on the E the wall has been opened, and a small room with niche is visible. This level can be reached by the external stair, crossing built in masonry and rupestrian spaces. We can presume the presence of a *matroneum* (Fig. 13).

The surface under the described elements is seriously compromised. A masonry structure closes the original access, that was originally located at the centre of the wall. A NE of the wall there is a second walled opening with jamb and arch made of two pieces of cut stone. At the height threshold there is a step, probably part of the original subsellium (Fig. 13).
